Peer Review of Highlands Neighborhood Traffic and Pedestrian Safety Plan

DRAFT REPORT

Prepared for:
Ada County Highway District

Prepared by:
SIX MILE ENGINEERING, PA

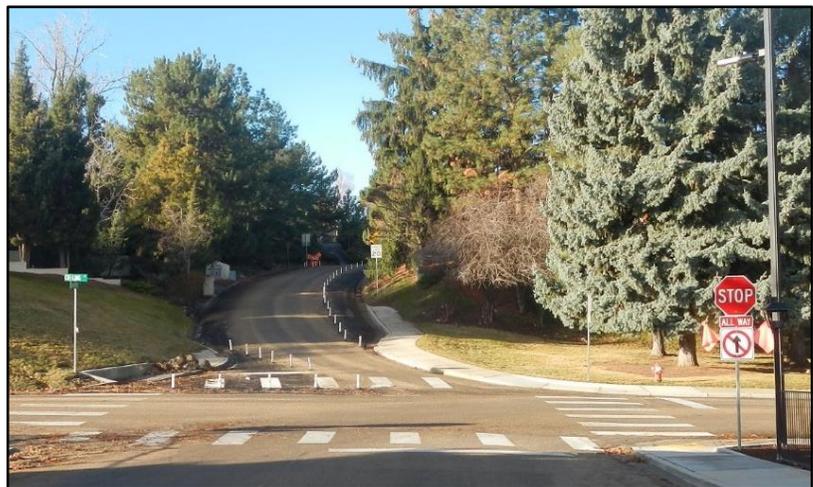
Figure 1-2. Traffic diverter at the intersection of Braemere Road and Curling Drive

- August 2016: ACHD implemented measures from the *Highlands Safety Plan* to reduce cut-through traffic on Lower Braemere Road. A diverter at intersection of Braemere Road and Curling Drive was installed to divert cut-through traffic to Curling Drive (Figure 1-2).

ACHD installed Alternative 2 in August of 2016 prior to the start of the school year. Stop signs on Curling Drive were installed plus additional signage on 15th Street, Bogus Basin Road, and Upper and Lower Braemere to notify motorists of the traffic pattern changes. The reduction to one southbound lane on Lower Braemere Road between Curling Drive and Ranch Road provided width to delineate a pedestrian pathway with channelizers (Figure 3-2).

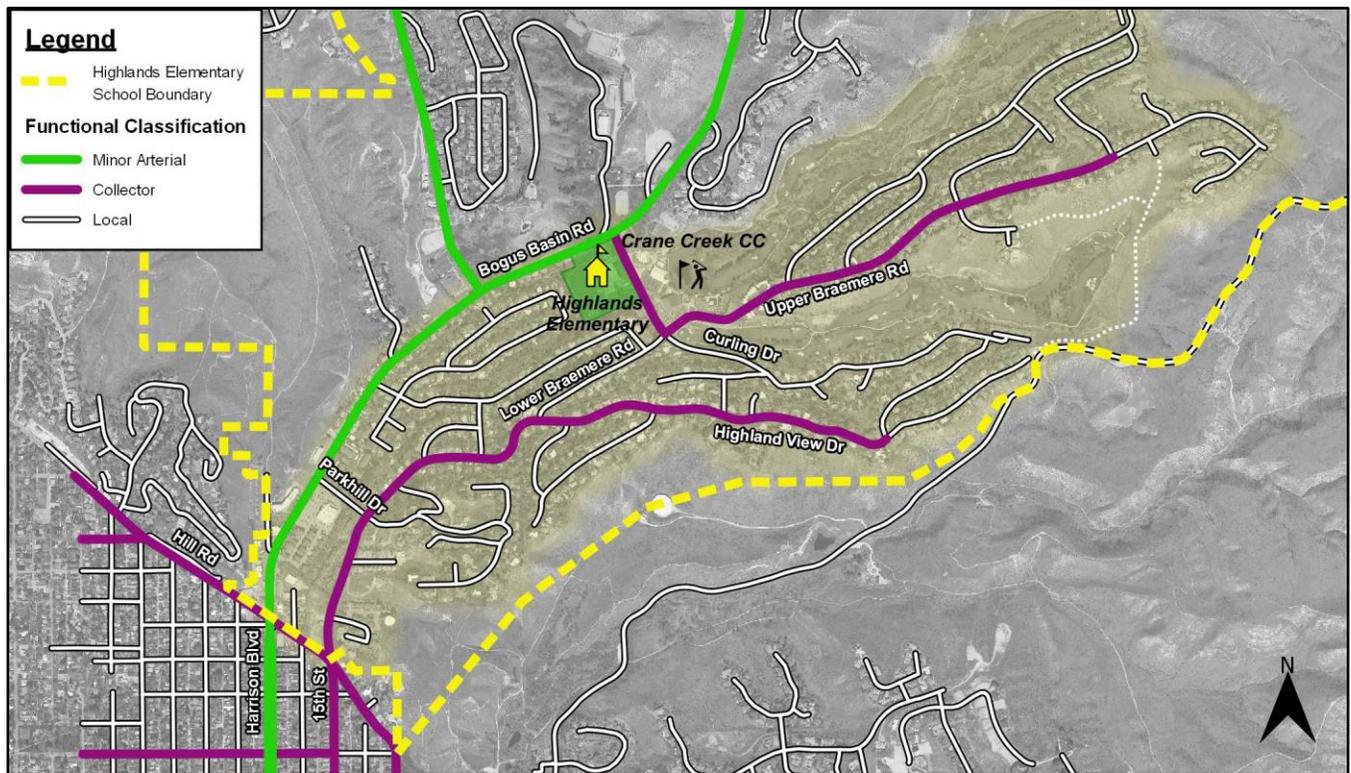
Figure 2-1. Study area, roadway functional classifications and Highlands Elementary boundary

The Highlands neighborhood study area is bounded by Bogus Basin Road to the west and Hill Road to the south (Figure 2-1). Land uses within the study area are primarily residential, with the exception of Highlands Elementary School and Crane Creek Country Club located on Curling Drive.

Neighborhood roadways are functionally classified as local streets, collector roads or minor arterial roads. Local streets are low-speed, low-volume roads that provide access to residences; collector roads are low-speed, low-to-moderate-volume roads that move traffic from local streets to arterial roads; minor arterial roads are low-to-moderate-speed, moderate-volume roads that move traffic from collector roads to major arterial roads. All local streets, collector roads and minor arterial roads in the neighborhood have front-on housing.

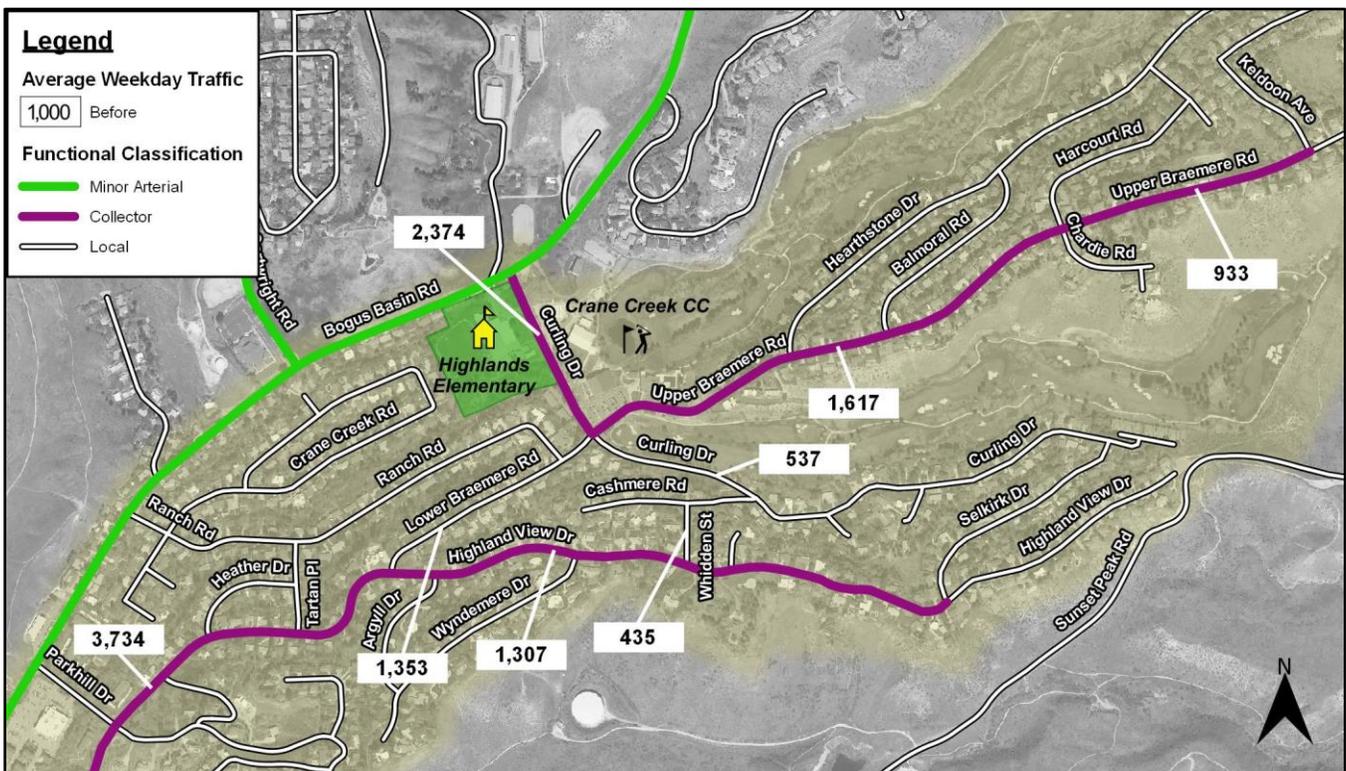
Figure 2-2. Vehicle volumes before mitigation measures

Average weekday traffic volumes on the key neighborhood roadways – collected before the diverter and all-way stop control mitigation was installed – are shown in Figure 2-2. Note that the volumes shown are weekday averages for the traffic counts taken, excluding holidays and early school release days. Daily counts varied by up to plus or minus 12 percent from the weekday average.

None of the neighborhood local streets or collectors exceed ACHD’s planning-level capacity thresholds of 2,000 vehicles per day (vpd) for local streets and 5,000 vpd for collectors. Also, none of the neighborhood collectors or minor arterials exceed ACHD’s peak-hour level of service (LOS) thresholds of 425 vehicles per hour (vph) for two-lane collectors and 550 vph for two-lane minor arterials.

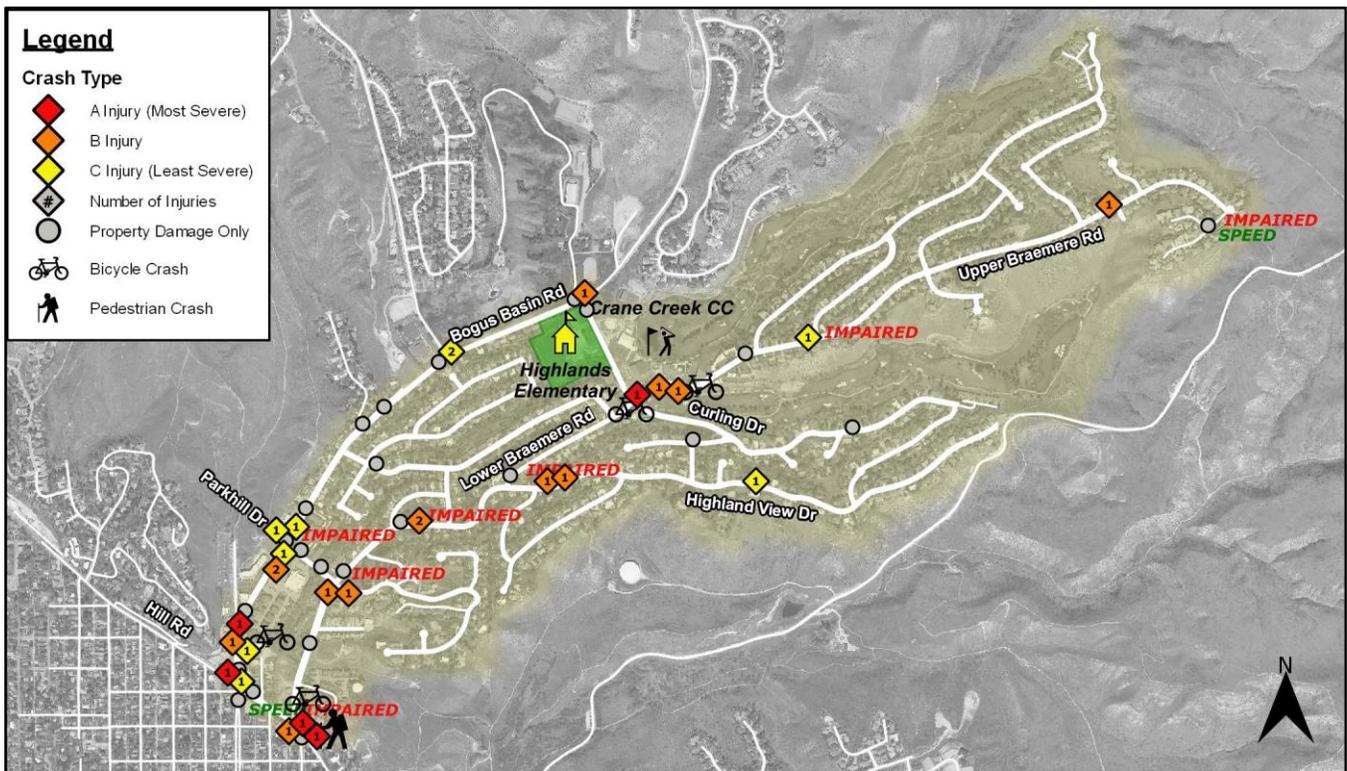
Figure 2-4. Reported crashes from 2011 to 2015

The most recent five-year history of reported crashes available is from 2011 to 2015. During that period, 48 crashes were reported in the Highlands neighborhood, with 25 injury crashes and no fatalities (Figure 2-4). There were no discernible trends in high crash frequency locations or contributing factors for crashes. Only one reported crash had speeding as a contributing factor.

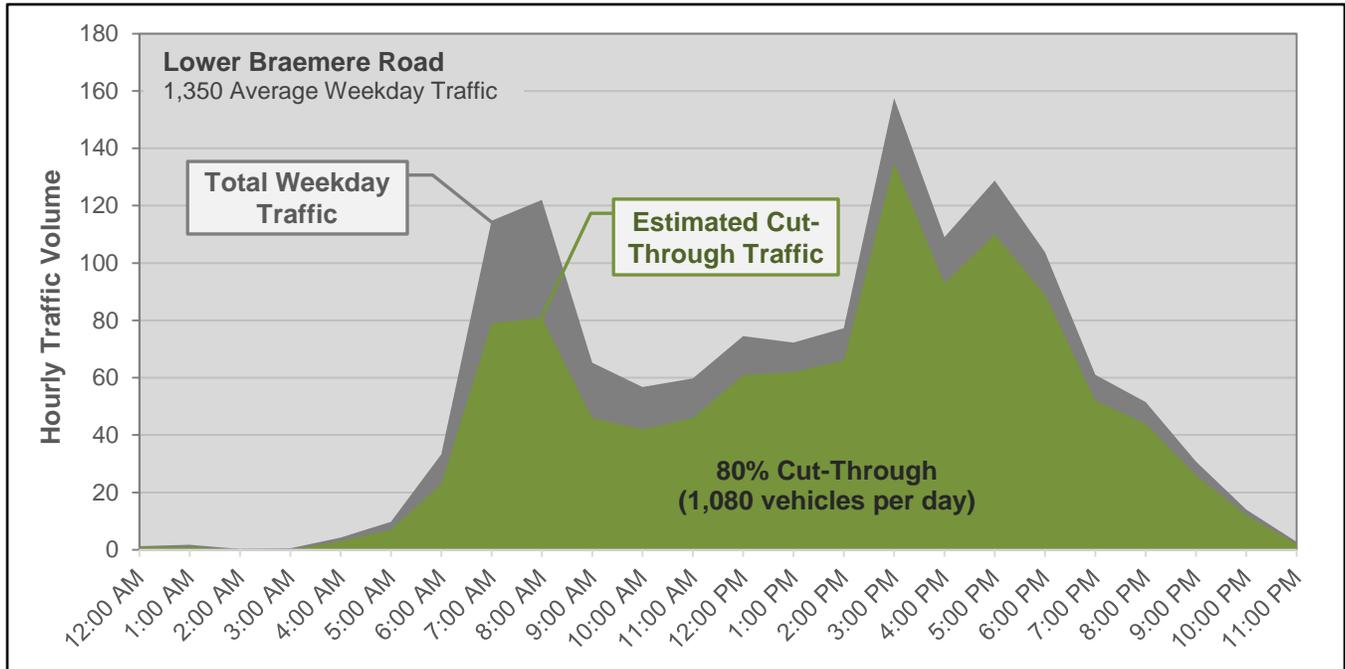
Figure 2-5. Estimated cut-through traffic on Lower Braemere Road before mitigation

Non-cut-through traffic on Lower Braemere Road was estimated by using distributing 95 percent of trips routed south on Lower Braemere and 5 percent north to and from Highlands Elementary,

Crane Creek Country Club, destinations on Bogus Basin Road, and a few trips to residences in the upper Highlands. Eastbound cut-through traffic on Lower Braemere Road is slight higher than westbound, which is consistent with the directional average weekday traffic where eastbound volumes are over 10 percent higher than westbound.

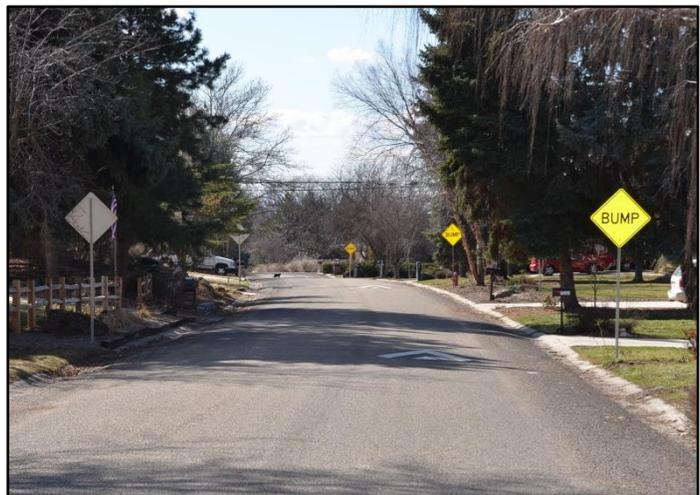
Figure 2-6. Cross-section view of Lower Braemere Road

With the traffic circulation pattern before implementation of the mitigation measures, Lower Braemere Road was operating as a collector street rather than a local street. Measured at approximately 27 feet from lip to lip, the street’s cross-section is narrower than other collectors in the neighborhood (Figure 2-6). Assuming that vehicles are parked adjacent to each other on opposite sides of the street, the remaining roadway width would only accommodate a single travel lane, with little buffer distance from the parked vehicles. As a result, yielding

would be necessary for opposing vehicles to pass between parked cars, causing encroachment into

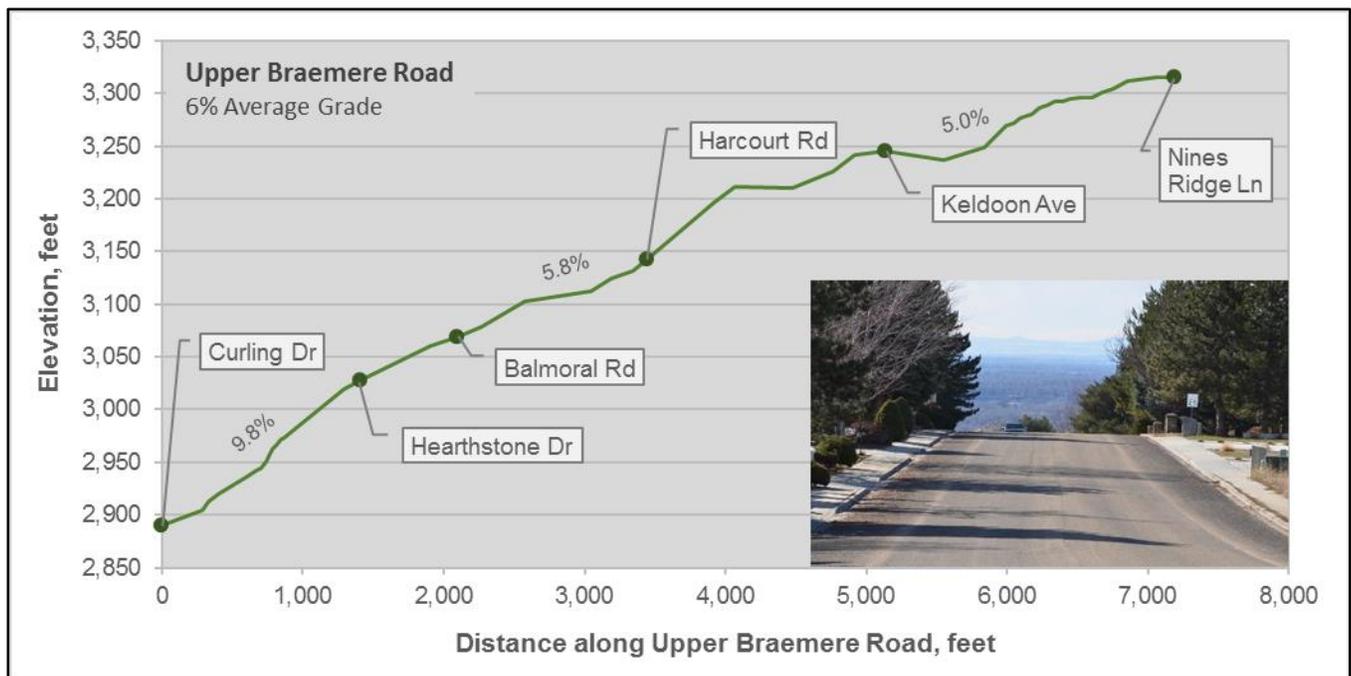
Figure 2-7. Upper Braemere Road cross section and grades

On Upper Braemere Road between Curling Drive and Keldoon Drive, the 85th percentile speeds were 7 to 10 mph over the posted speed limits. Near the Crane Creek clubhouse driveway and golf cart crossing, the 85th percentile speed for westbound traffic was 35 mph which is 15 mph over the 20 mph posted speed limit at that location. A contributing factor to excessive speeds is the steep grade on Upper Braemere Road (Figure 2-7).

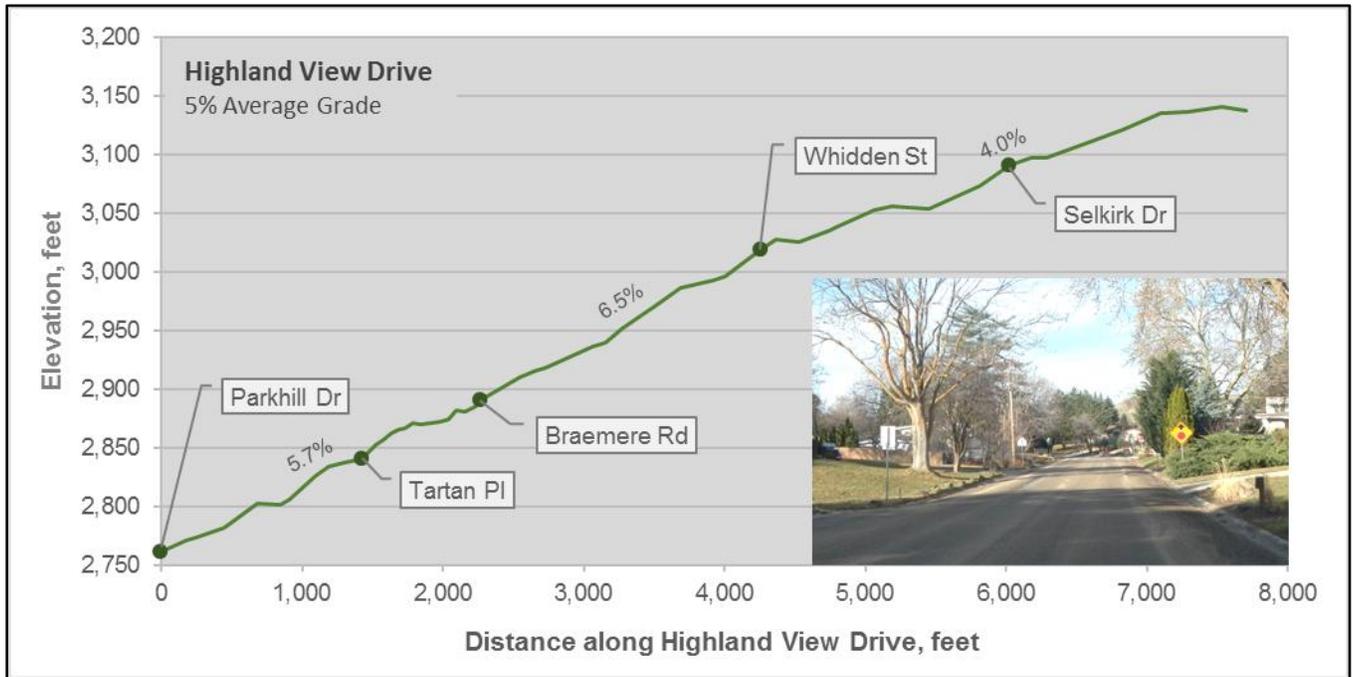
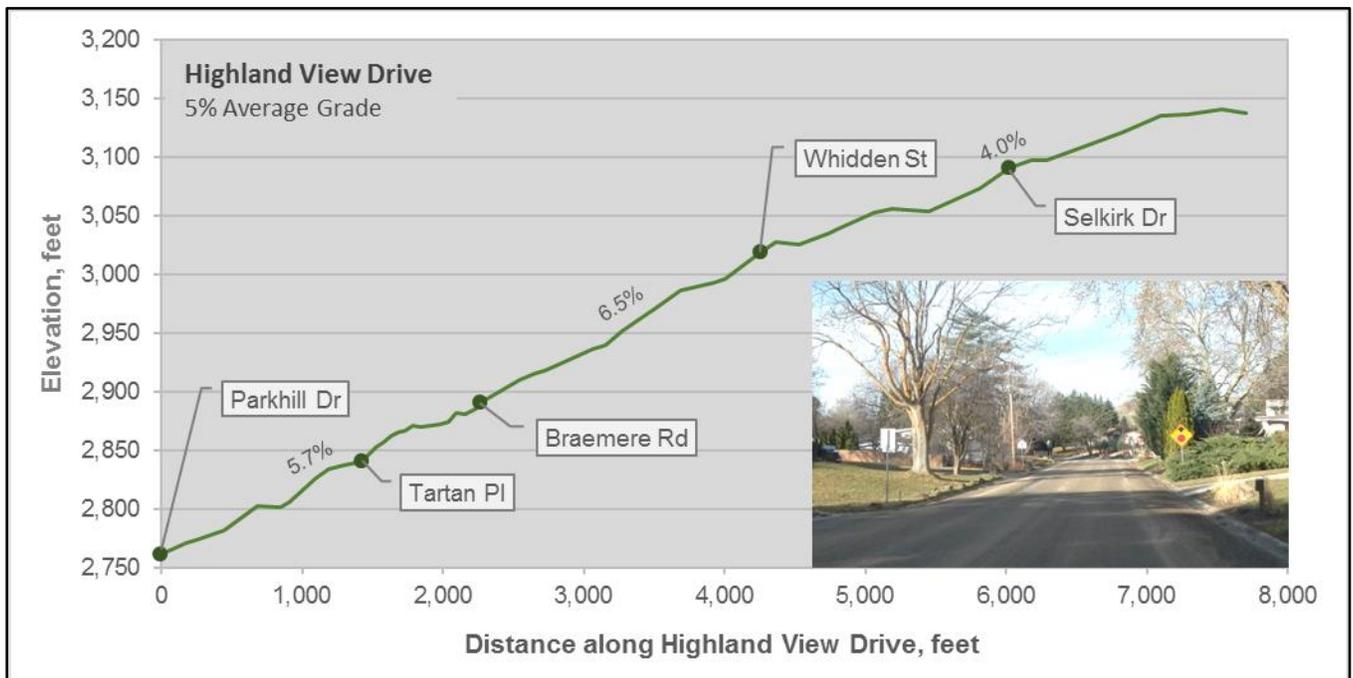
Figure 2-8. Highland View Drive cross section and grades

Speed counts on Highland View Drive prior to the mitigation were not available for this study, but speeding issues have been identified by ACHD and Highlands residents. Highland View Drive has a similar roadway typology and grade as Upper Braemere Road, so similar excessive speeds may have occurred in the before condition (

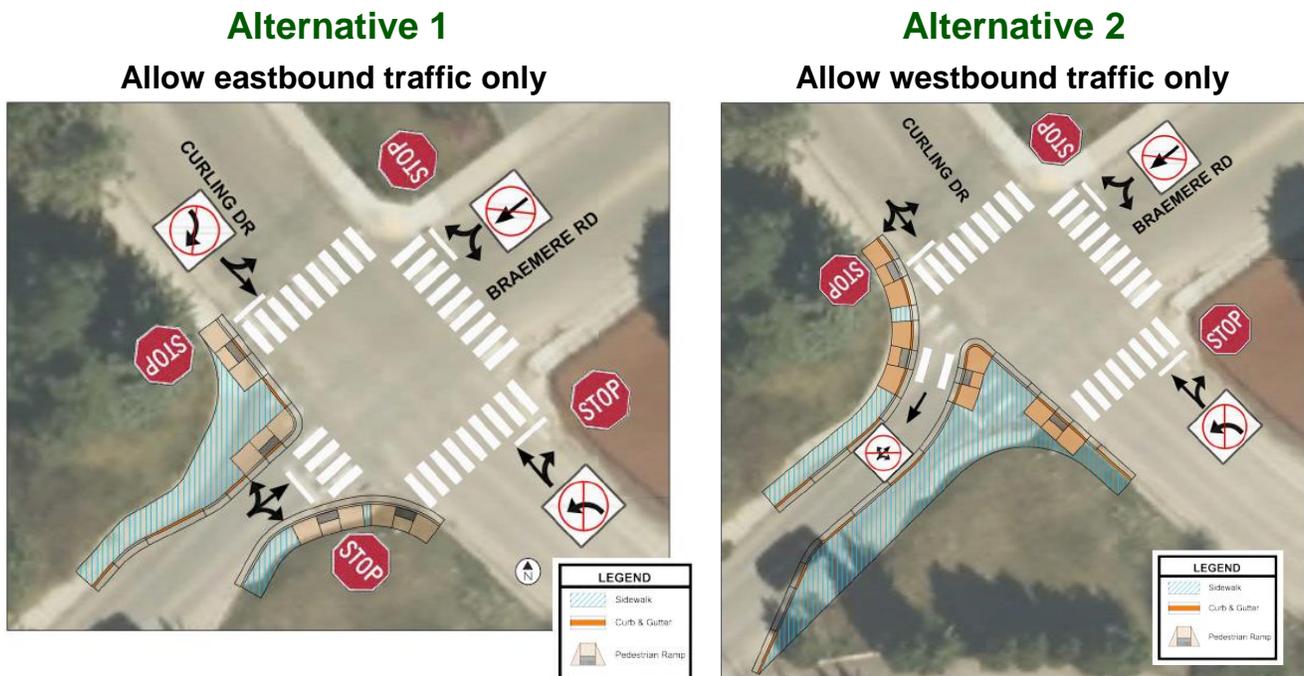
Figure 3-1. Cut-through traffic mitigation measures developed by ACHD

To reduce the estimated 1,080 daily cut-through trips on Lower Braemere Road, ACHD considered several mitigation ideas at the Curling Drive and Braemere Road intersection and developed two alternatives (Figure 3-1). The alternatives were presented at the April 2016 public open house meeting for consideration by residents who were also solicited for additional ideas to mitigate Lower Braemere Road cut-through traffic.

Both of the ACHD alternatives eliminate one direction of travel on Lower Braemere Road at the Curling Drive intersection. Alternative 1 would have a smaller impact on altering neighborhood circulation, but would not reduce as much cut-through traffic as Alternative 2. Alternative 1 restricts westbound cut-through traffic but does not prohibit eastbound cut-through traffic, potentially reducing cut-through traffic by 45 to 50 percent, which equates to a 35 to 40 percent reduction in total traffic on Lower Braemere Road. Alternative 2 restricts eastbound traffic but allows westbound right-turns from Curling Drive to Lower Braemere Road, potentially reducing cut-through traffic by 85 to 90 percent, which equates to a 70 to 75 percent reduction in total traffic.

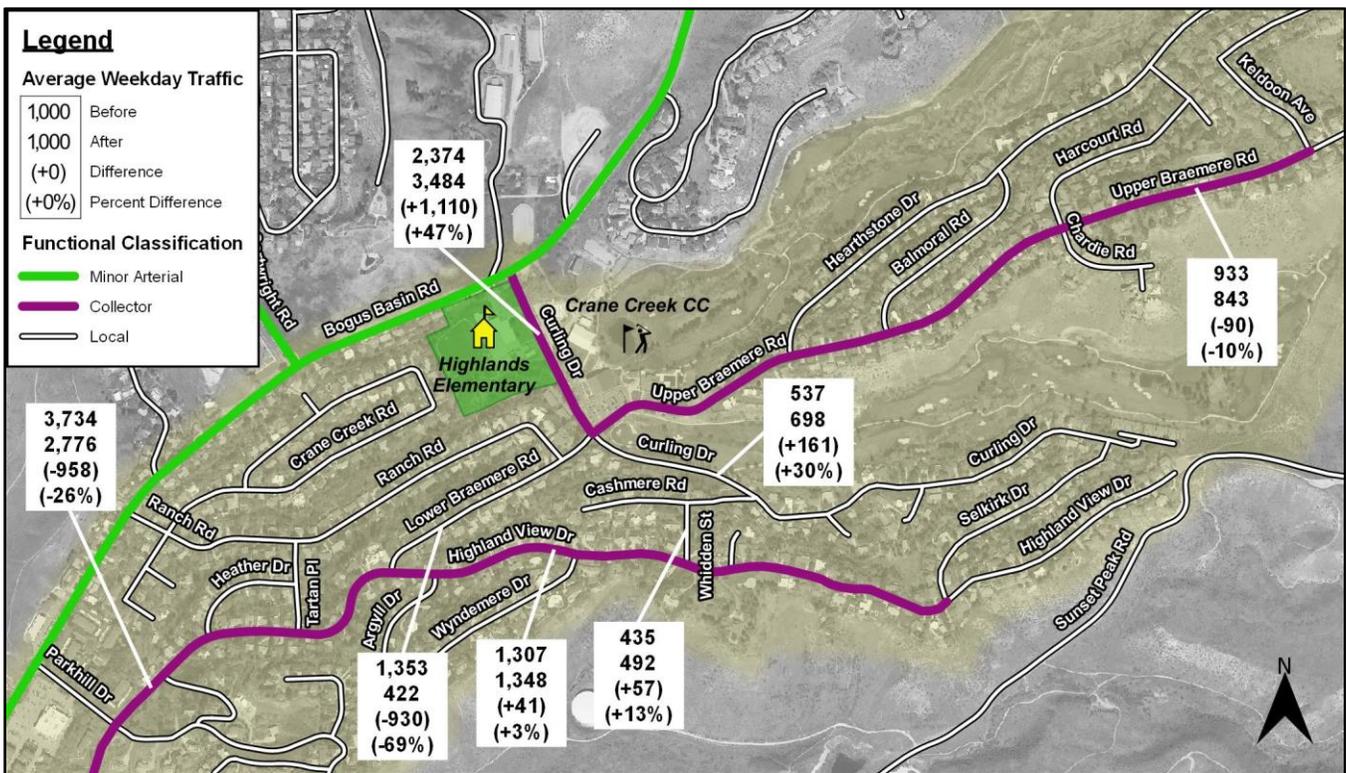
Figure 3-4. Average weekday volumes – before, after, difference and percent difference

The majority of the 930 vehicles per day re-routed from Lower Braemere Road now travels on the collector segment of Curling Drive between Upper Braemere Road and Bogus Basin Road. On this segment of Curling Drive, the before and after counts were not collected at the same location. Before counts were obtained near Crane Creek parking lot and after counts were approximately 500 feet north near the school pedestrian crossing. As a result, the increase in traffic volume on Curling Drive may be overestimated because the before count may be low by potentially not capturing some school drop-off and pick-up traffic originating and returning to locations outside the Highlands neighborhood.

Traffic was reduced on Highland View Drive between Lower Braemere Road and Parkhill Drive by approximately the same amount as the traffic reduction on Lower Braemere Road. Small increases in re-routed traffic occurred on other local streets such as Whidden Street and Ranch Road, but were less than 60 vehicles per day (maximum of 10 additional vehicles in peak periods).

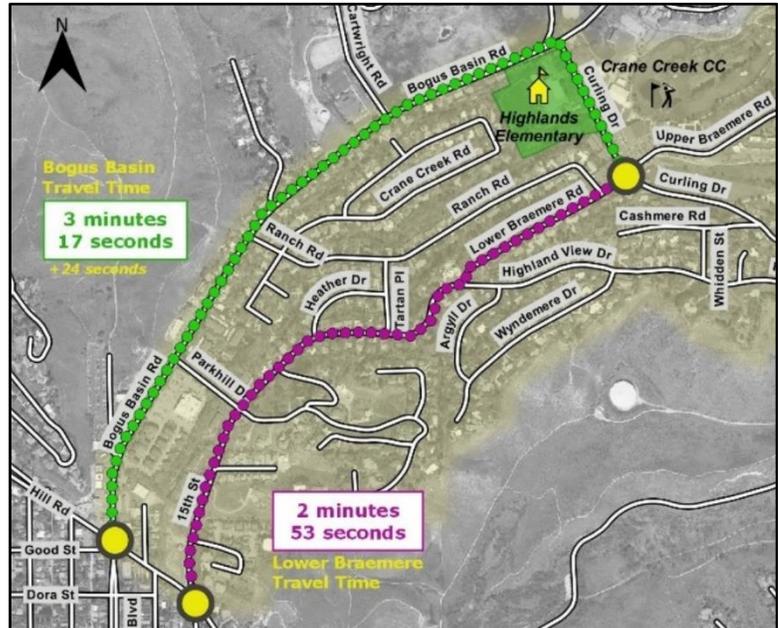
Figure 3-5. Travel time comparison averaged for three peak periods

The travel times during the three peak periods (AM peak hour/ school arrival, PM school release, and PM peak) were measured on the Lower Braemere Road route (pre-diverter route) and Bogus Basin Road route (post-diverter route) as shown in **Error! Reference source not found.** On average, the Bogus Basin Road route is 24 seconds longer than the Lower Braemere Road cut-through route.

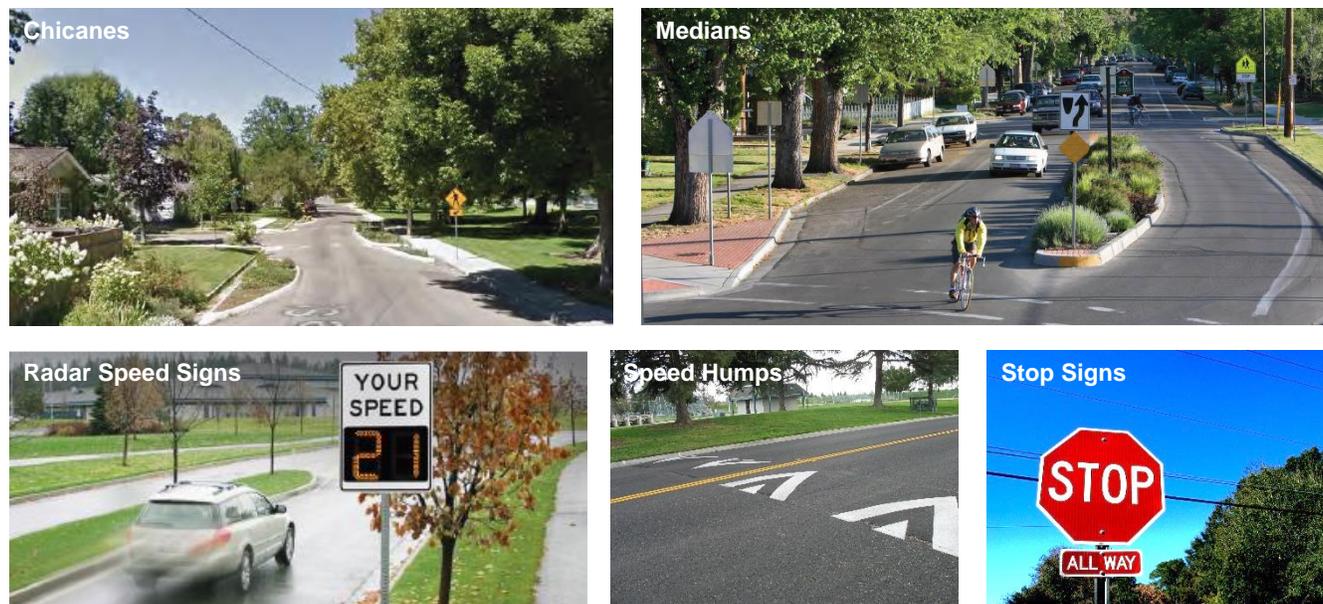
Figure 3-6. Speed mitigation measures evaluated by ACHD

To reduce speeding on Upper Braemere Road and Highland View Drive, ACHD proposed several options to the Highlands residents (Figure 3-6 on page 21). The speed mitigation options for both roadways included radar speed signs, speed humps, and all-way stop control. On Upper Braemere

Road, mitigation options also included chicanes and medians which physically narrow the roadway to reduce speeds.

ACHD evaluated the speed mitigation options and recommended installing stop signs on both Upper Braemere Road and Highland View Drive, plus alternating the radar speed sign annually between both roadways. They eliminated the other mitigation options – speed humps were unsupported, chicanes on Upper Braemere Road were hard to retrofit and reduced parking – and deferred installing medians on Upper Braemere Road to see if the all-way stop mitigation was effective.

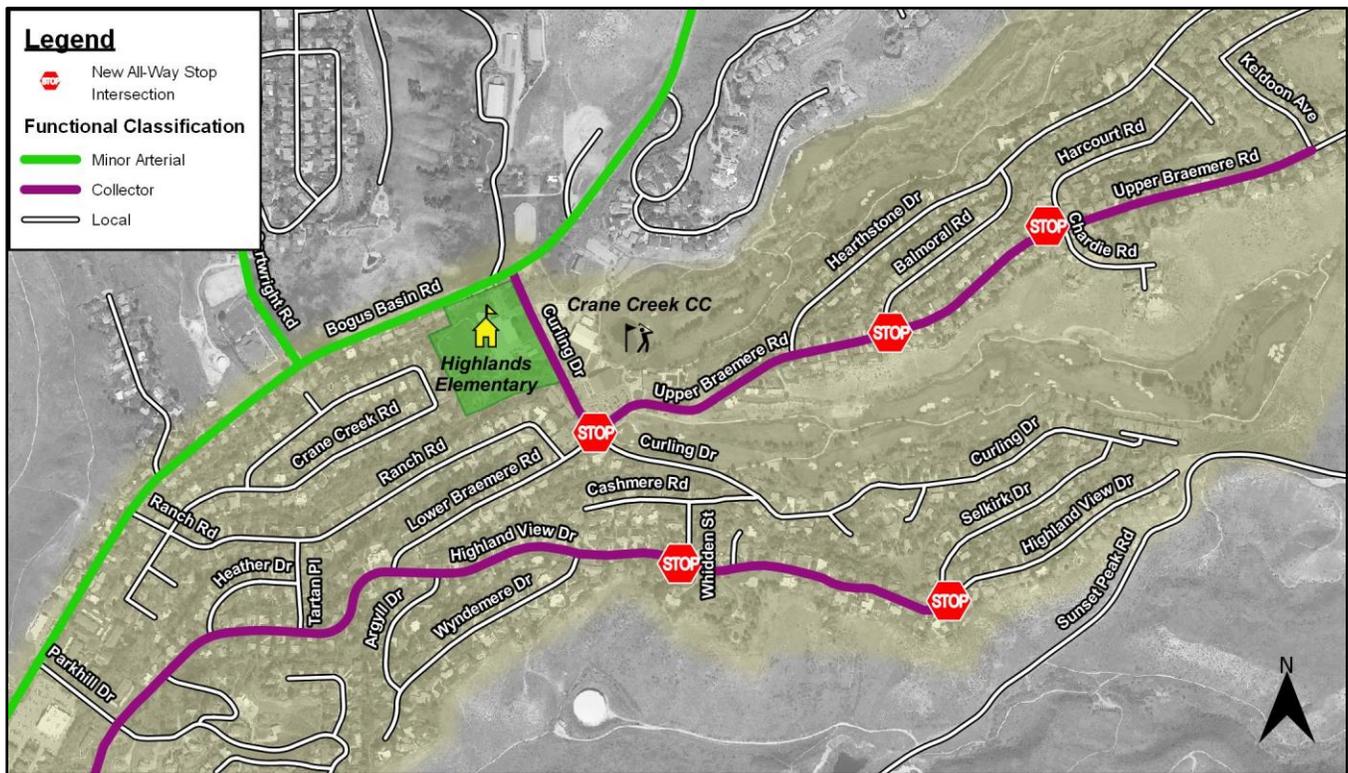
Figure 3-7. New all-way stop intersections

In July 2016, stop signs were installed on Curling Drive at the Braemere Road intersection, on Upper Braemere Road at the Balmoral Road and Harcourt Road/Chardie Road intersections, and on Highland View Drive at the Whidden Street and Selkirk Drive intersections (Figure 3-7 on page 22). A secondary potential benefit of the stop sign installations is that they provide pedestrian crossing opportunities across the collector streets.

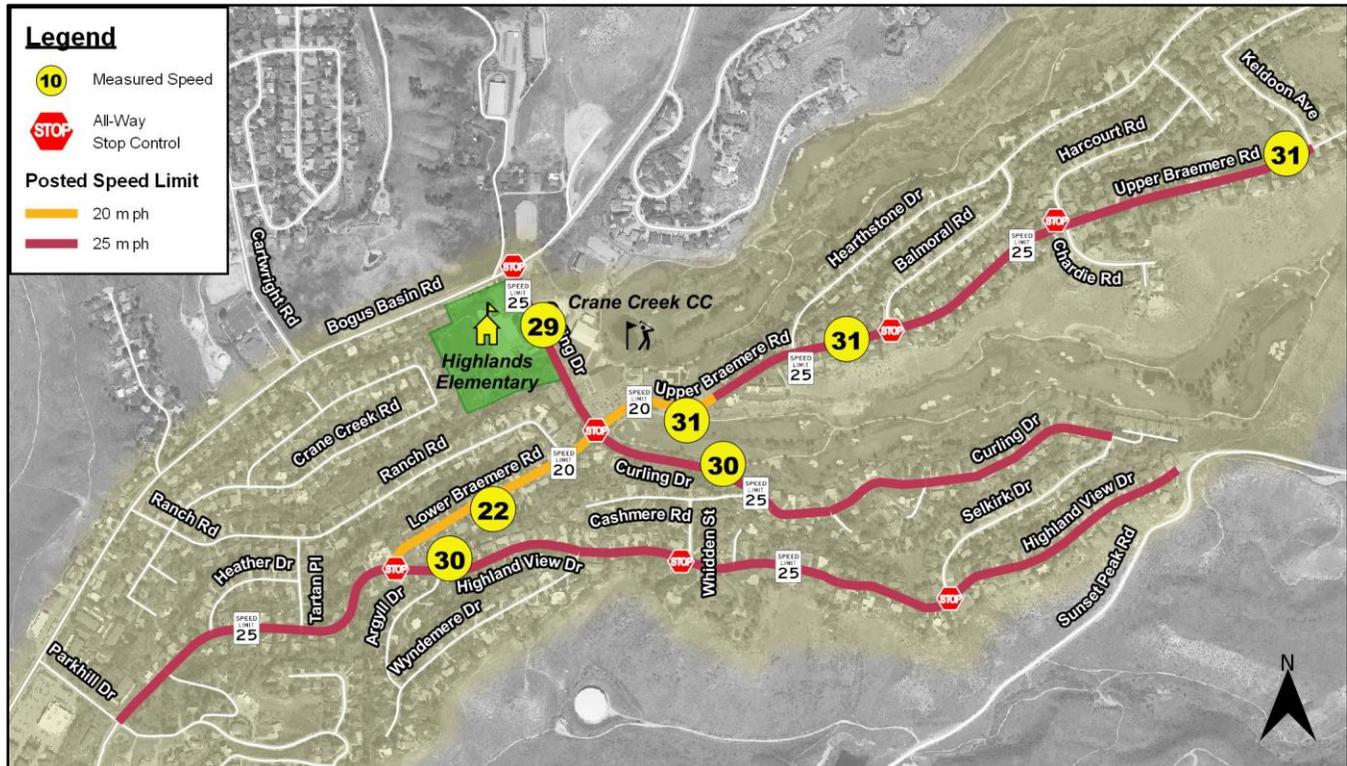
Figure 3-8. 85th percentile speeds after stop sign mitigation

On Upper Braemere Road, the 85th percentile speed decreased by 3 mph to 31 mph between Hearthstone Drive and Balmoral Drive. East of Keldoon Avenue, a 2 mph decrease was calculated. However, the after counter was located within 50 to 100 feet of the intersection and may have captured vehicles slowing to turn to and from Keldoon Avenue, so the before and after results are not comparable. On the steep 20 mph (posted speed) segment north of Curling Drive, the measured 85th percentile speed was 31 mph or 11 mph over the limit. The before speed data was not collected. A second speed study using a radar gun instead of tubes measured an 85th percentile speed of 29 mph in the 20 mph segment.

On Highland View Drive, the after 85th percentile speed was 30 mph east of Argyll Drive – before speed counts were not collected to determine if a reduction occurred. The Lower Braemere Road 85th percentile speed reduced by 1 mph to 22 mph. On the local street section of Curling Drive east of Braemere Road, the 85th percentile speed decreased by 4 mph to 30 mph.

At Curling Drive between Braemere Road and Bogus Basin Road, the AM and PM school zone speeds are not reported because the counters proximity to the pedestrian school crossing and school driveway resulted in erroneous readings due to stop-and-go school traffic. The school zone data was removed from the remaining speed count data. For the non-school-zone hours, the 85th percentile speed decreased by 2 mph to 29 mph.
